## **Experimental investigation into the behaviour of a water-filled, DN 250, PN10 Fiber glass Reinforced thermosetting resin pipe when heated according to IMO A 753 (18) level 3**

Report no.	2022-Efectis-R000006
Sponsor	Génie du Composite Etude et Réalisation (GCER) Usine et Siège Social: Route de Thrayet 4041 Ksibet sousse TUNISIA
Prepared by	Efectis Nederland BV
Author(s)	P.B. Reijman B.Sc. R.D. Scheepe B.Sc.
Project number	ENL-21-000589
Date of issue	January 2022
Number of pages	12

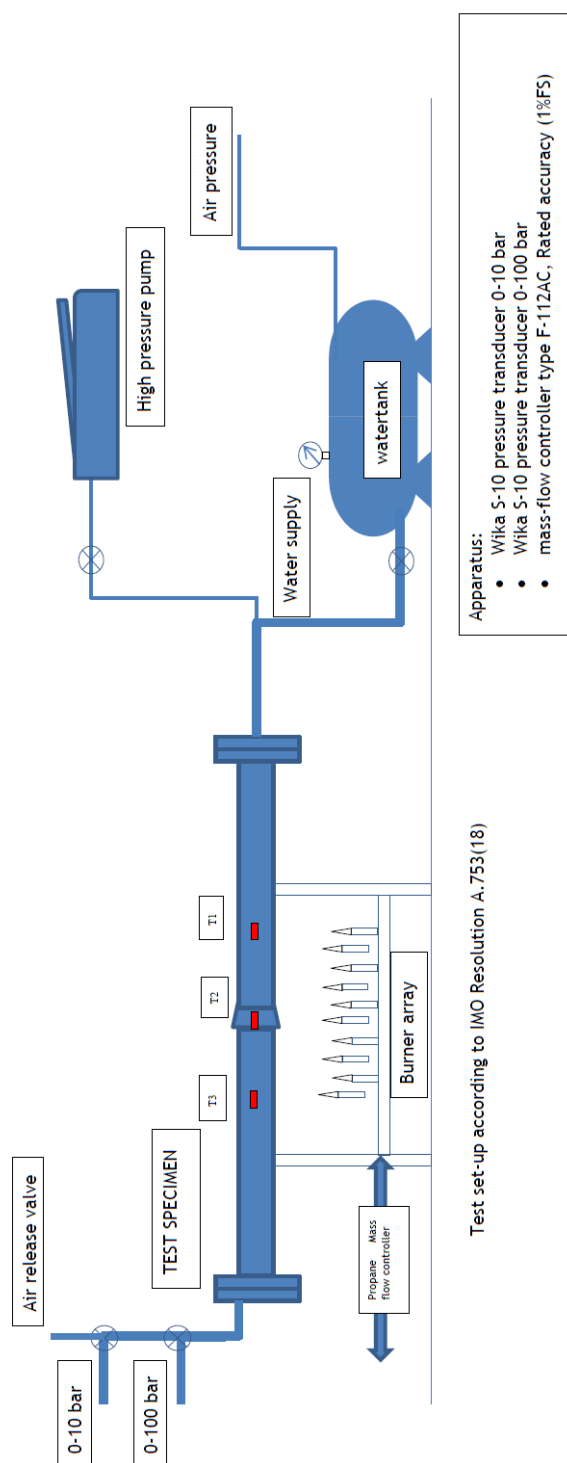
Figure A1 Test setup

For an overview of the test set-up refer to Figure A1.

The pipe spool rested freely in a horizontal position on a steel frame.

The test configuration as specified in the IMO resolution A753(18) was used for testing the 250 mm pipe spool described in this report. In order to supply the designated overpressure of 10 bar a hydraulic pump was used.

The test set-up is shown in figure A1 and photo D1.

For the location of the various above mentioned measuring devices it is referred to Figure A1.

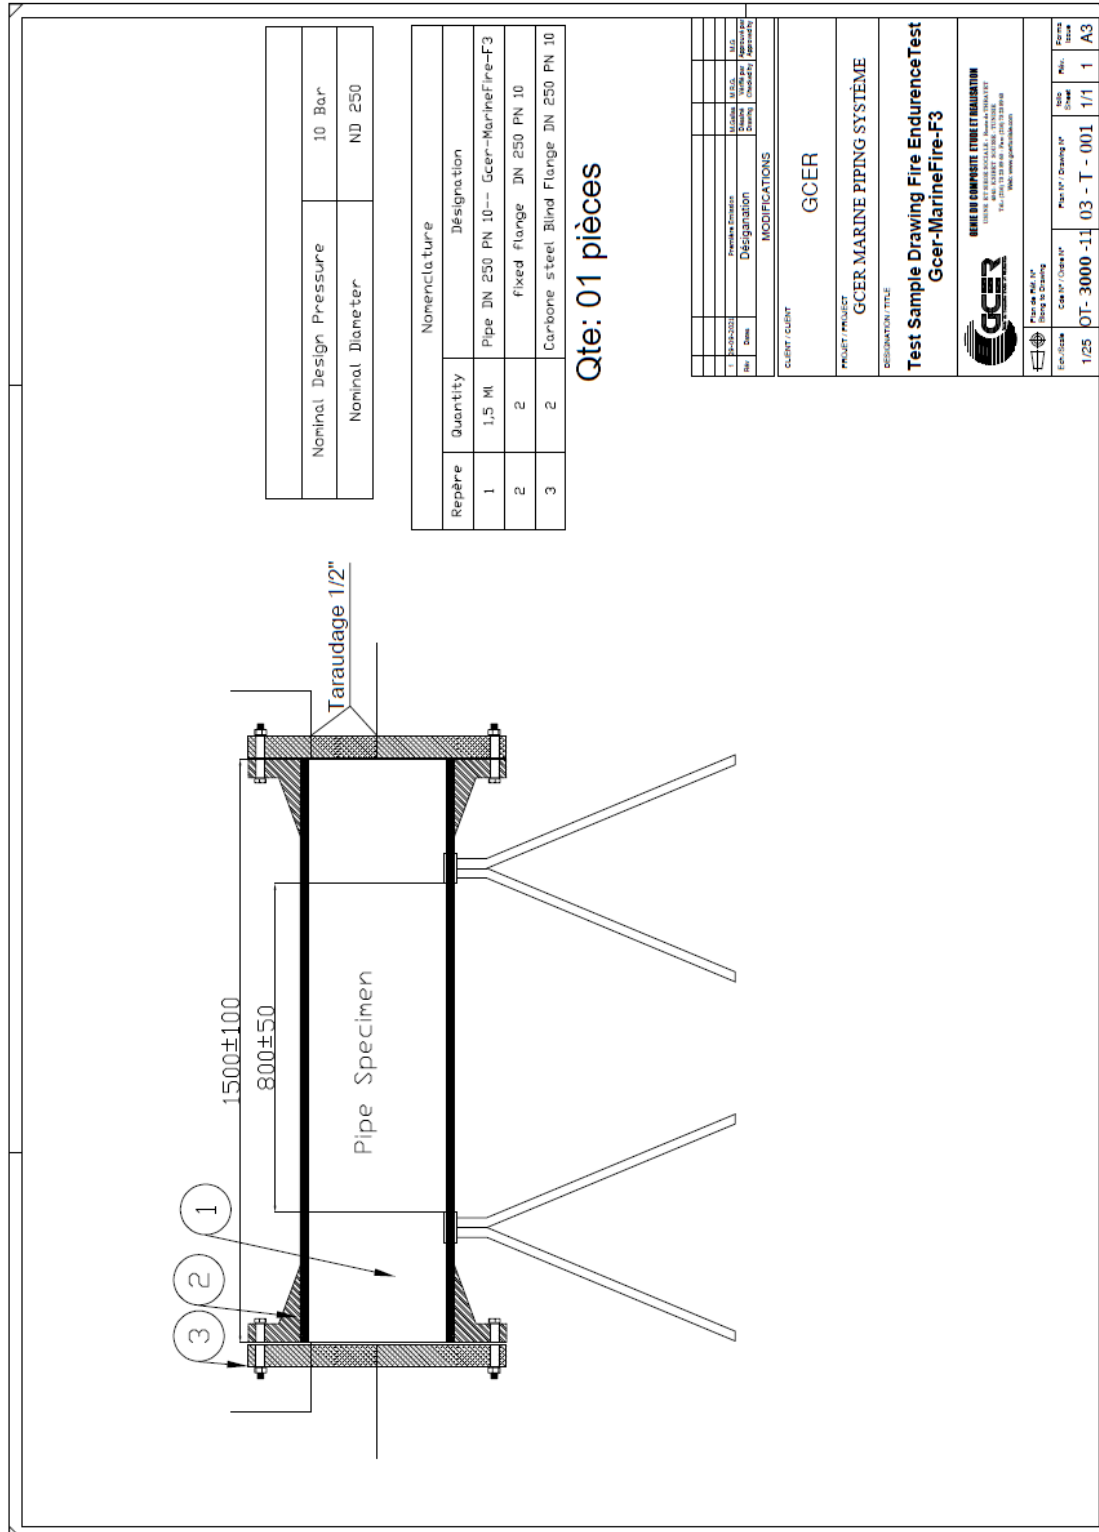
Figure B1      Technical drawing of test specimen

The test specimen consisted mainly of an Epoxy pipe spool with stub end flanges at both ends. The dimensions and technical data, of the test specimen are presented in annex B.

The test specimen was provided with steel blind flanges at both sides.

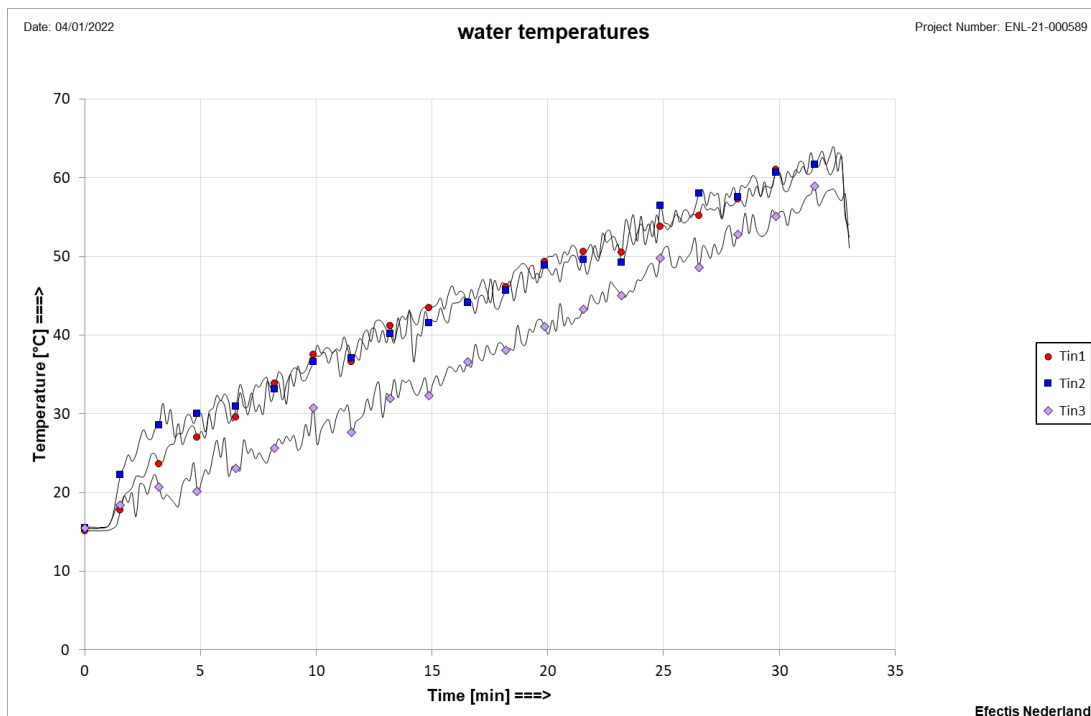
Figure C1 Measured water temperatures during fire test

- water temperatures with three sheathed thermocouples with a diameter of 1.6 mm (Twat1-3);
- water pressure in the pipe by means of an electronic pressure gauge, type Wika 1155305 accuracy 0.01 bar;
- the fuel flow rate by means of a mass-flow controller model F-112AC-FA-55-V with a rated accuracy of (1% FS).

The water temperatures are measured in the pipe spool and are presented in figure C1.

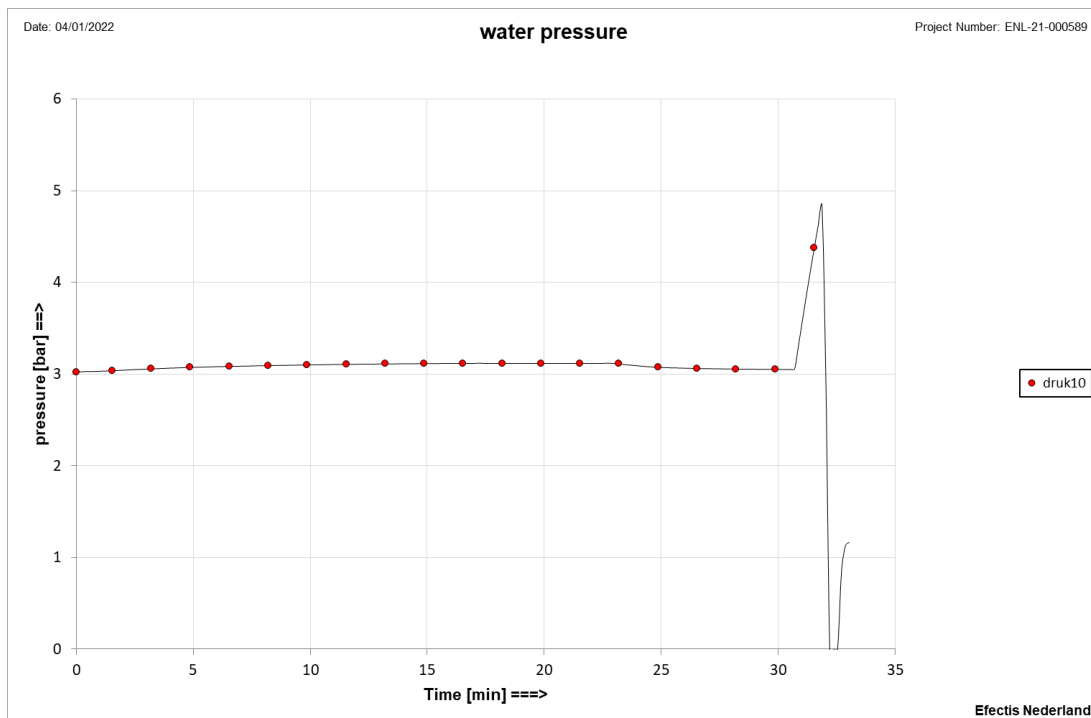
Figure C2 Measured water pressure during fire test

The water pressure is measured in the pipe spool and is presented in figure C2.

The water pressure was kept constant and amounted to  $3 \pm 0.5$  bar.

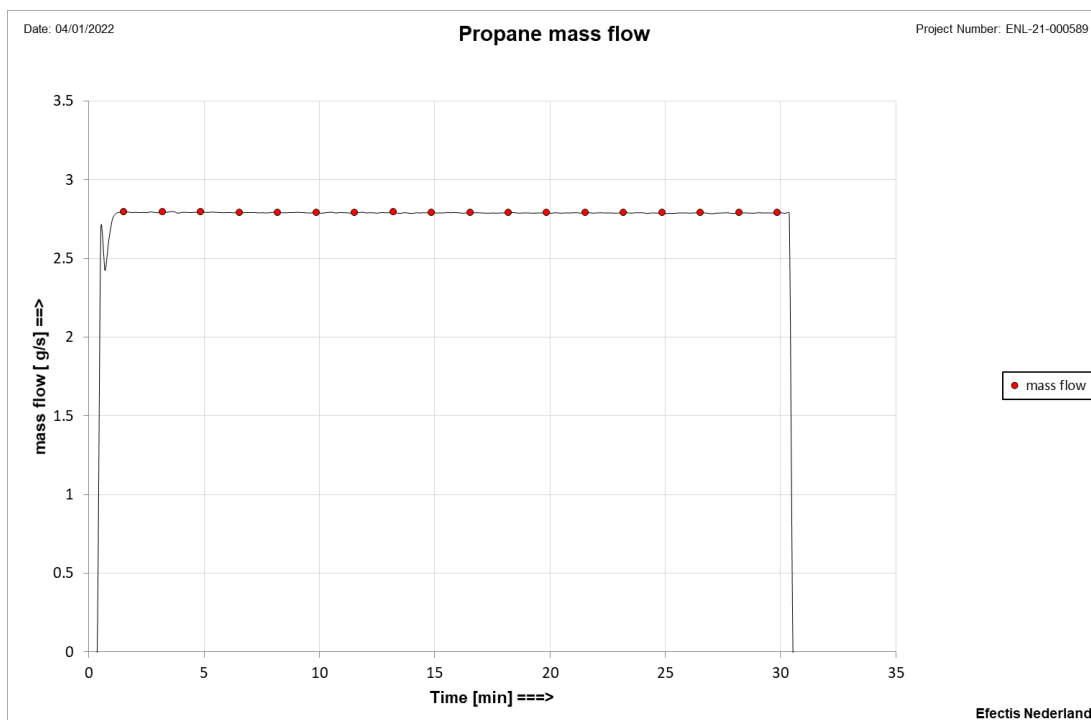
Figure C3 Measured heat release of burner array

The propane fuel flow rate was regulated as required, with a mass-flow controller model F-112AC-FA-55-V with a rated accuracy of (1% FS), to achieve the designated heat release rate of 130 kW. This heat release rate corresponded to a pre-mix flame propane with a fuel flow rate of 10 kg/h for an array of four rows of five burners.

Gas consumption of the burner array is measured and is presented in figure C3.

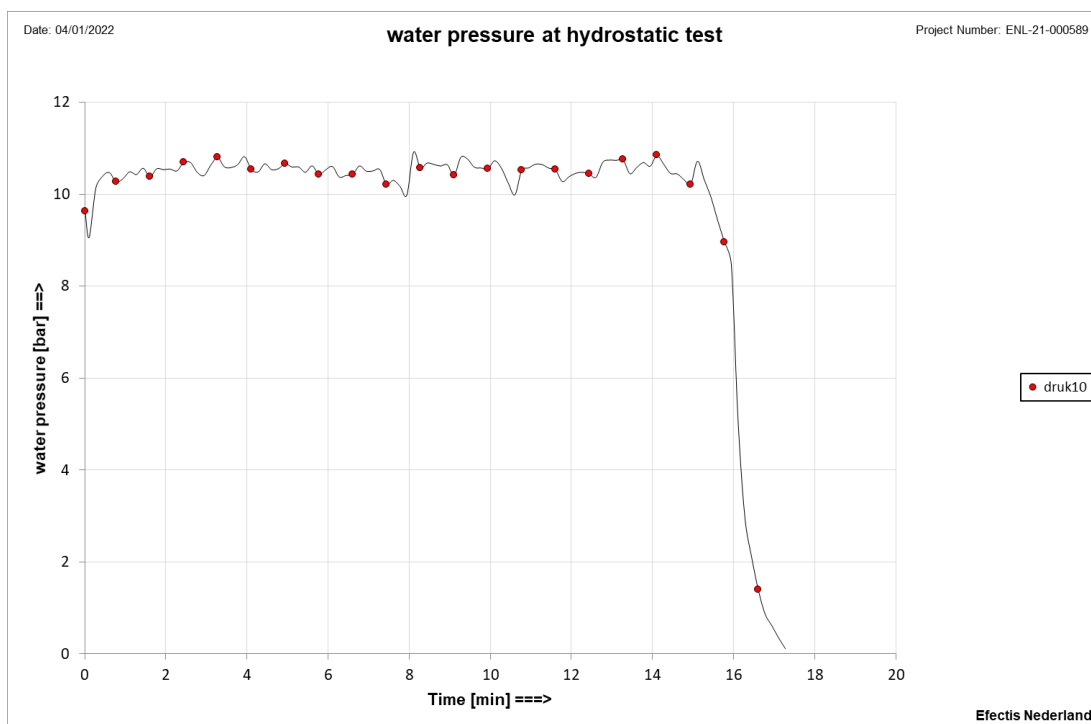
Figure C4 Measured water pressure during hydrostatic pressure test

The test specimen was pressurised up to 10 bar overpressure, during a period of 15 minutes. The pressure was remained constant. During this period the water pressure was measured, and possible leakage was measured.

Over a testing period of 15 minutes at a test pressure of 10 bar no leakage occurred.

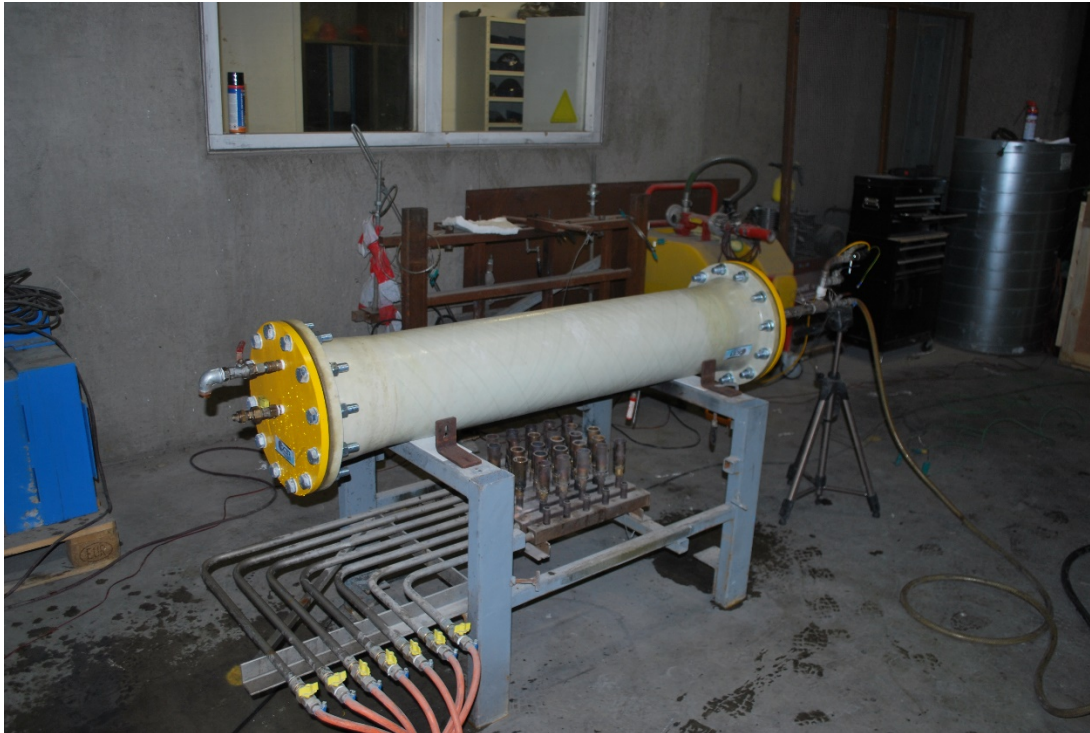
Figure D1 Specimen before test

For a view of the test specimen refer to Photo D1.

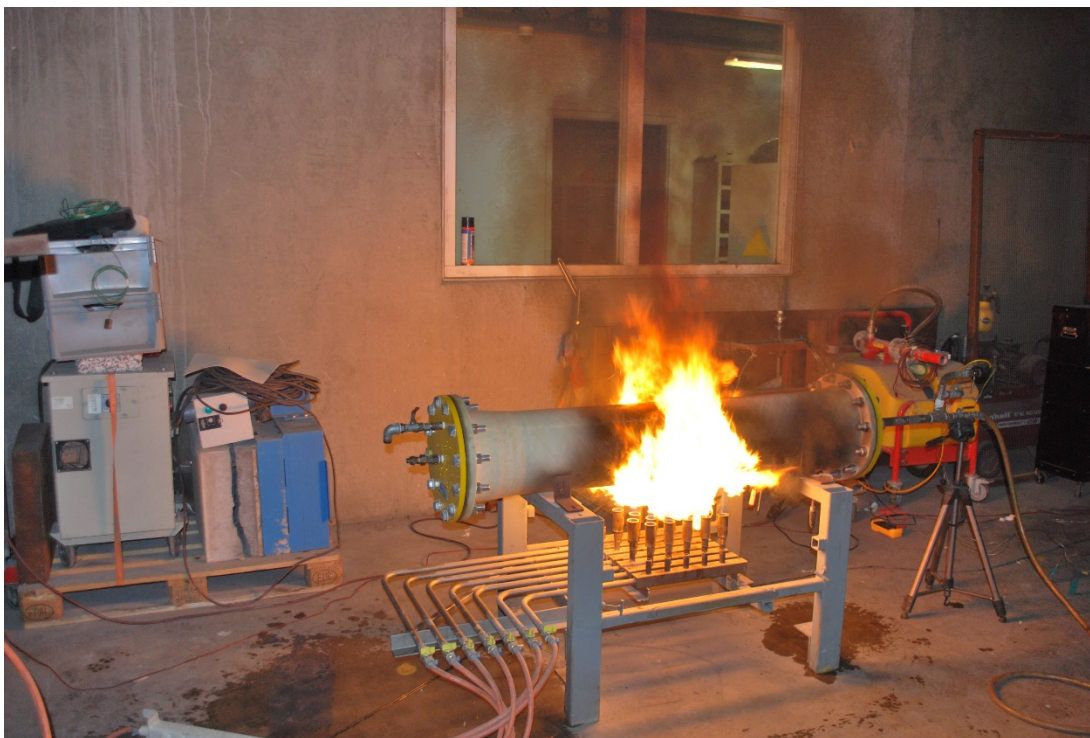
Figure D2 Specimen during heating

Aim of the fire endurance test was to assess the performance of the Epoxy pipe spool when exposed to a propane multiple burner with a fast temperature increase. See Photo D2.

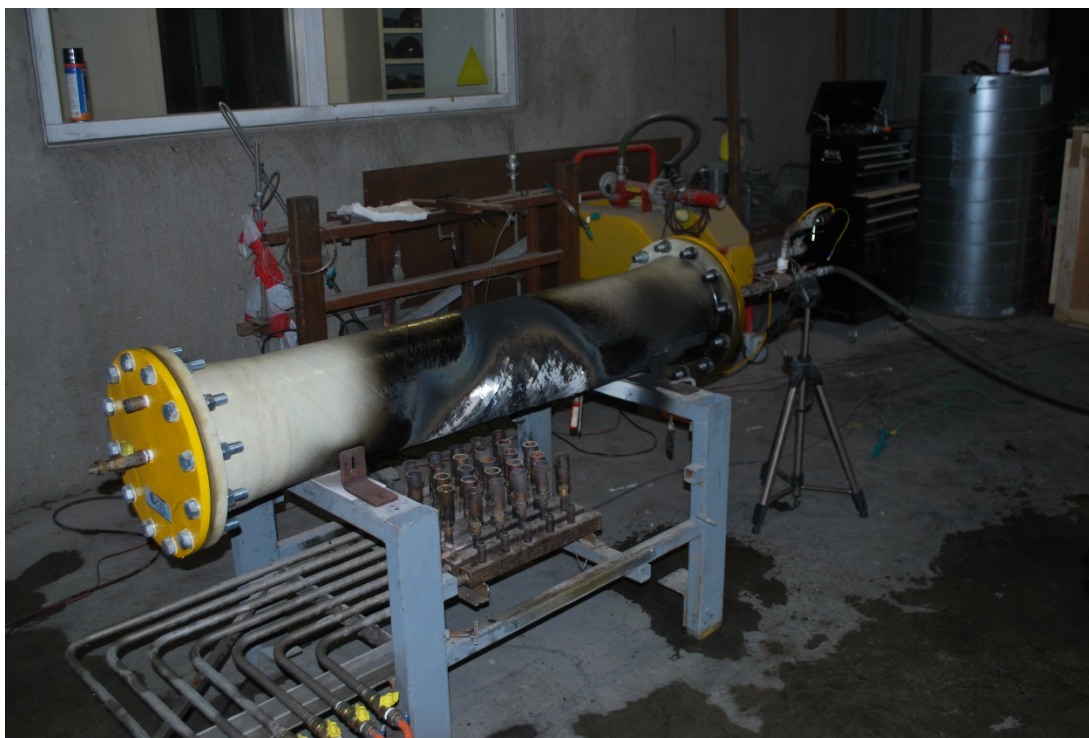
Figure D3 Specimen during the hydrostatic pressure test
